## THE CHALLENGE

**UnderWater Inspection in Lieu of Drydocking (UWILDs)** are often required to ensure the structural and operational integrity of a marine asset. In current economic climates where saving cost is a key driver and safety and structural integrity are of critical importance, UWILD inspection programmes are becoming far more commonplace.

### ACFM UWILD - GoM

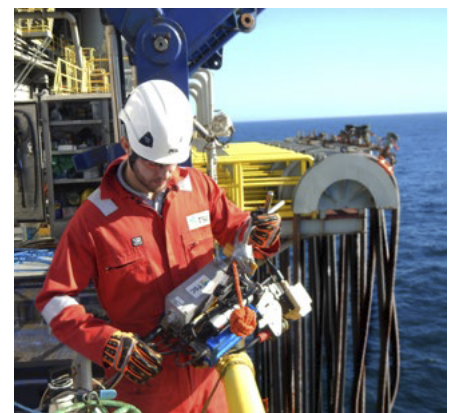
Far Left: ACFM crack inspection on leg-to-pontoon weld using the MagCrawler™.

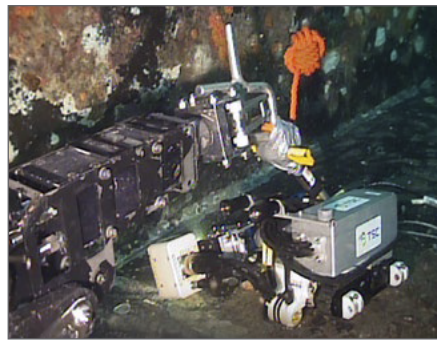
In response to this and other environmental factors, TSC's Engineering solutions team have developed the ACFM® MagCrawler™. This unit has been designed specifically to enable the ROV deployment of ACFM® Array Probe Technology underwater, and can inspect a wide variety of subsea geometries including circumferential, fillet and full penetration welds in pipes and plates. Ideal for restricted access areas the MagCrawler™ is rated up to 150m (493ft) and is a robust, magnetic-tracked, remotely operated vehicle equipped with

cameras. Traction is achieved by two rubber caterpillar tracks that are easily manoeuvrable on horizontal and vertical planes, as well as inverted surfaces. Probes are mounted onto the crawler with a metal sprung arm for passive compliance with the surface and a 360° rotational head allows full weld coverage. An electronic rotary encoder is also on board to determine the position of the crawler and simultaneously collect distance measurements whilst scanning.

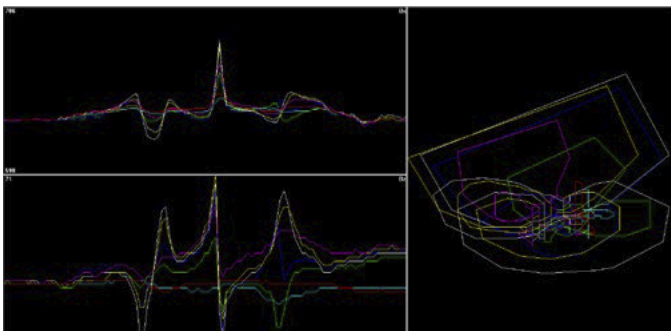
Figure 1 is an example of a function check scan performed before the inspection containing three defects (20mm x 2mm) in different orientations.

The data collected was of high quality at all locations allowing for accurate signal analysis by the ACFM® operators. As function checks were carried out before and after each daily inspection shift, a comparison between signals containing a defect and live inspection signals could be accomplished (see examples above).

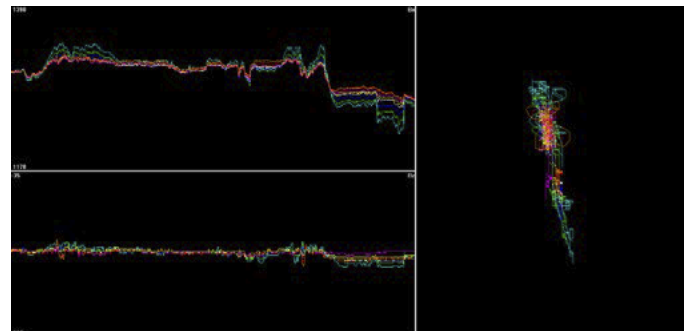
Figure 2 shows an examples of comparative data from the column 2 aft weld with no defects detected. This was consistent throughout the campaign.
